Debris/Ice/TPS Assessment and Integrated Photographic Analysis for Shuttle Mission STS-57

July 1993

Gregory N. Katnik
NASA/Kennedy Space Center

DEBRIS/ICE/TPS ASSESSMENT
AND
PHOTOGRAPHIC ANALYSIS
OF
SHUTTLE MISSION STS-57

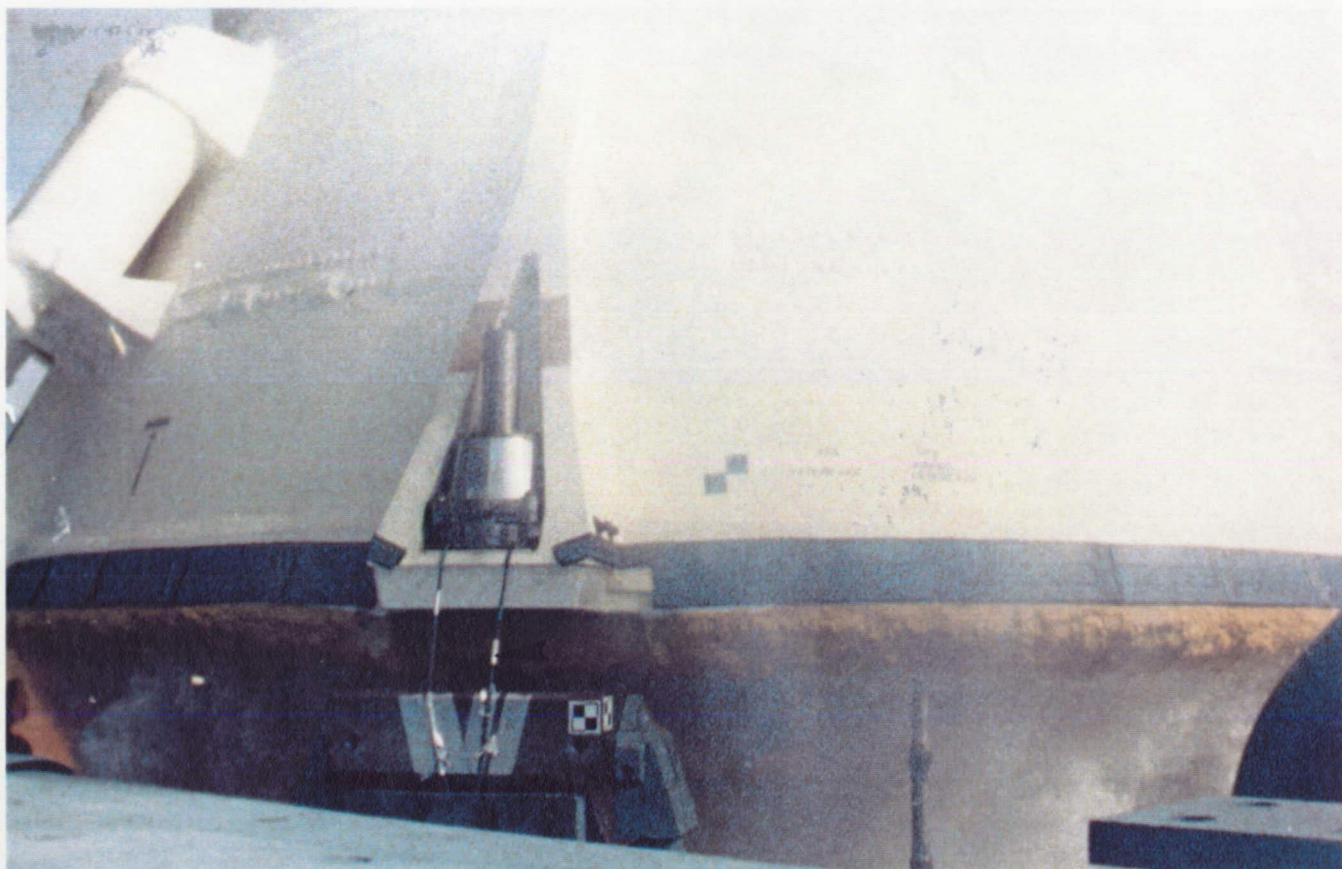
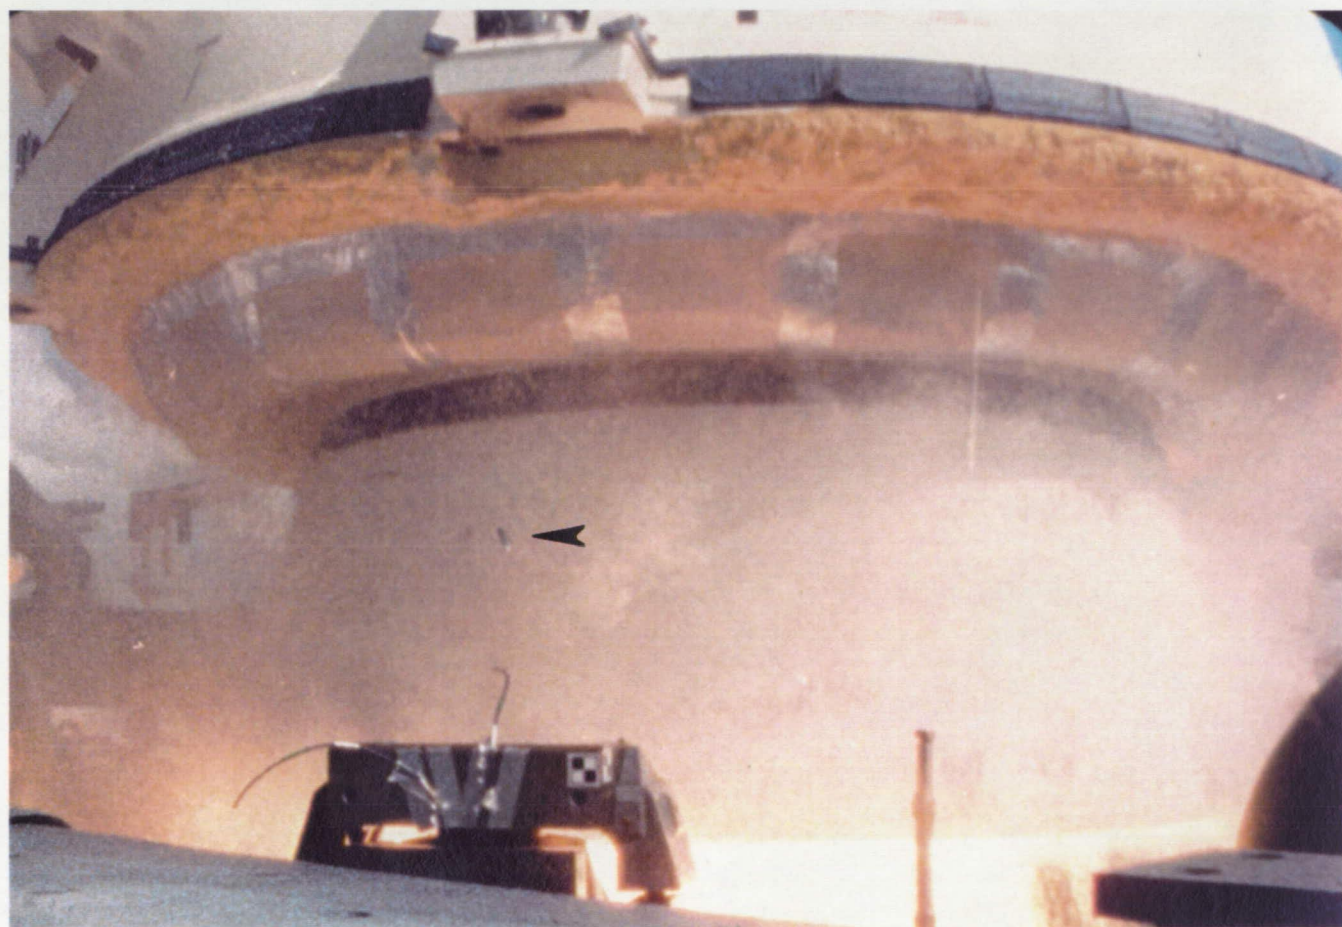
Two frangible nut pieces fell from the HDP #2 DCS/stud hole after liftoff.

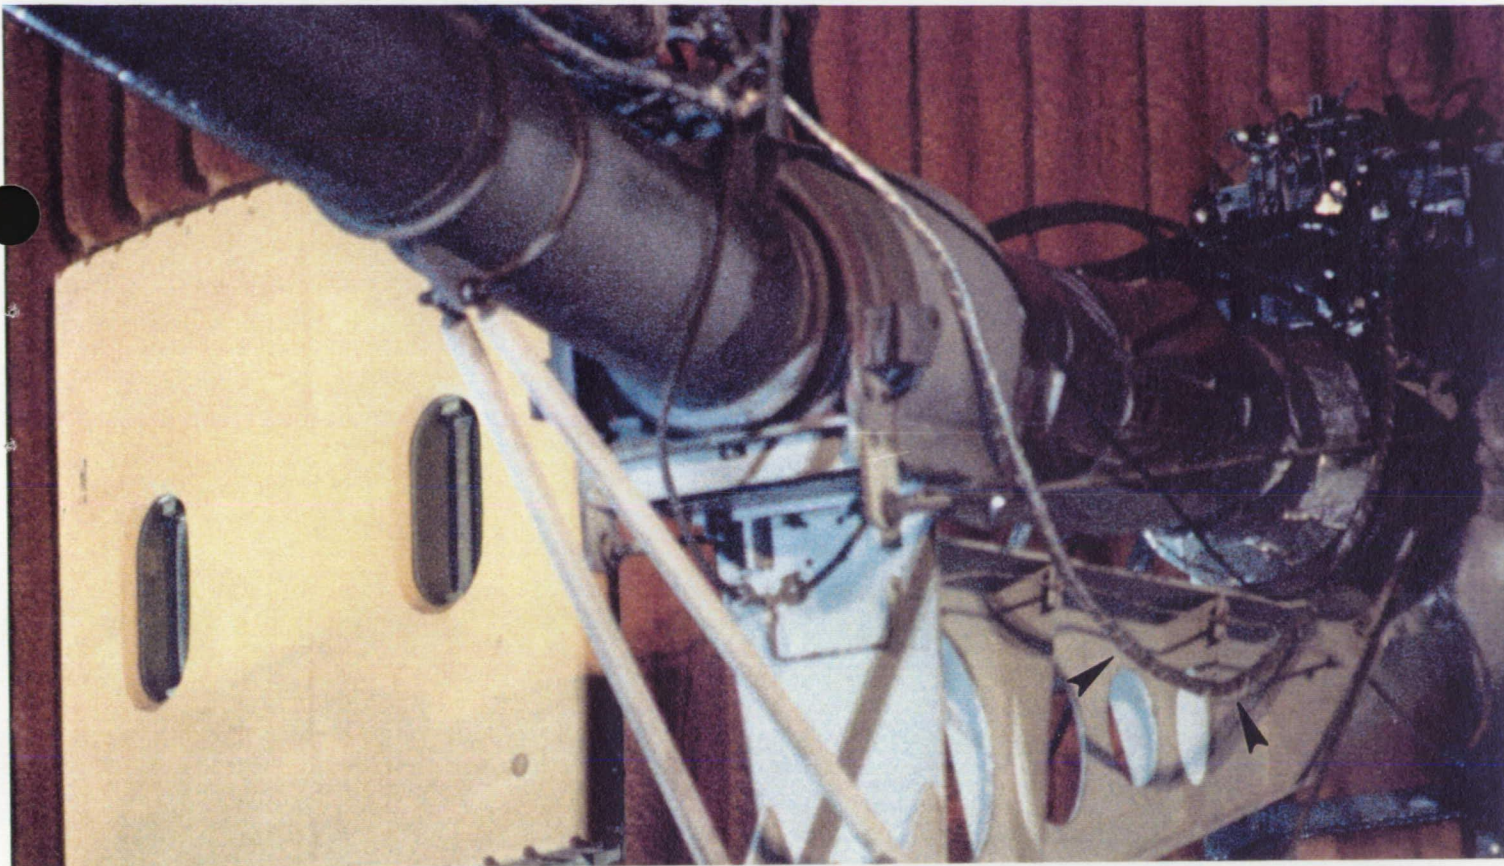
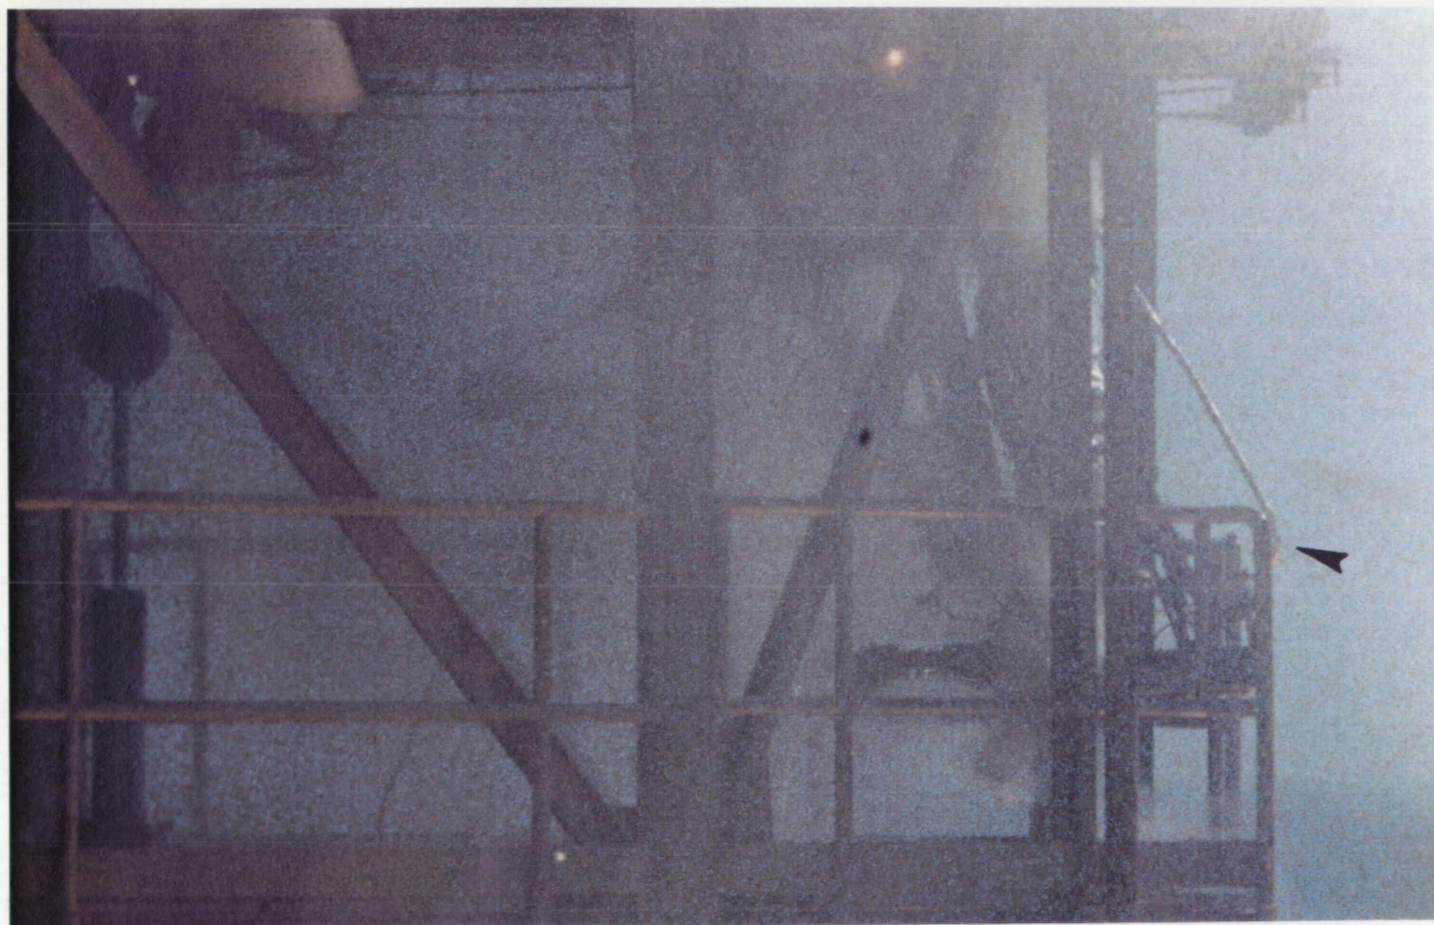
Excessive slack on the cable attached to the GUCP J2 electrical connector caused the cable to momentarily catch on an intertank access platform hand rail during retraction.

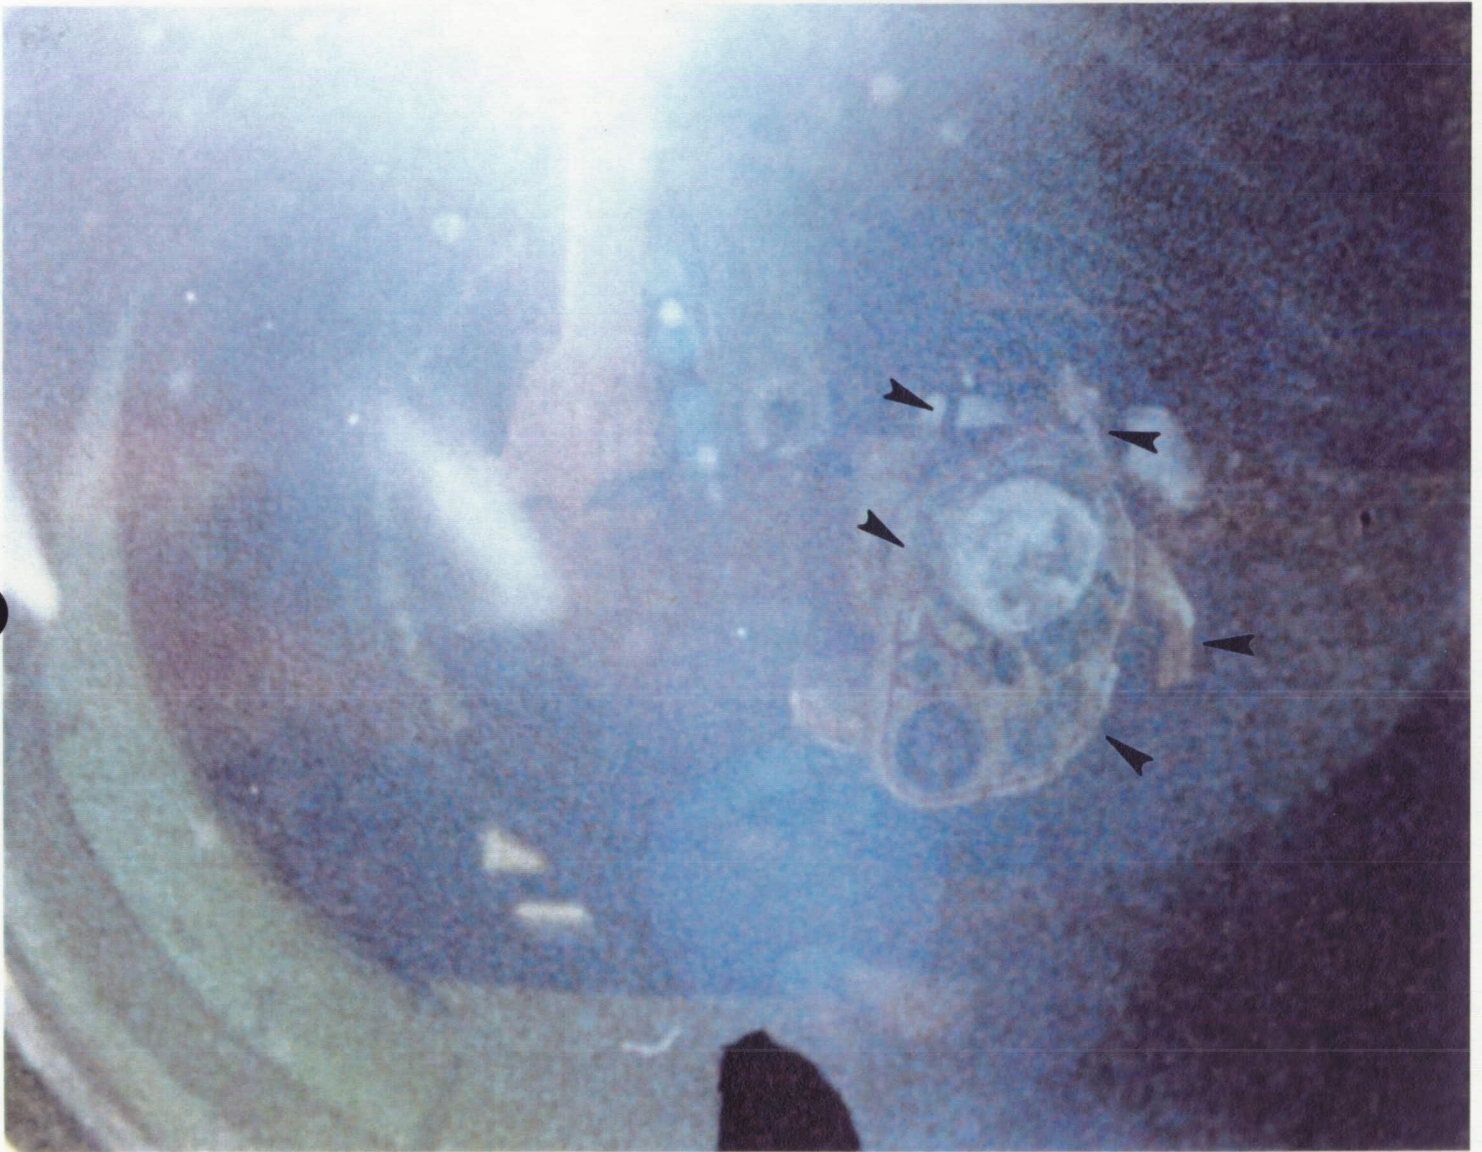
The red purge seal was missing from the ET/ORB LH2 umbilical near the 4-inch disconnect and at the top outboard section. TPS was damaged on the inboard side of the umbilical and a large piece of foam, which measured approximately 2 feet long by 4 inches wide by as much as 1 inch thick, had partially separated from the umbilical. TPS on top of the umbilical had peeled back in two places.

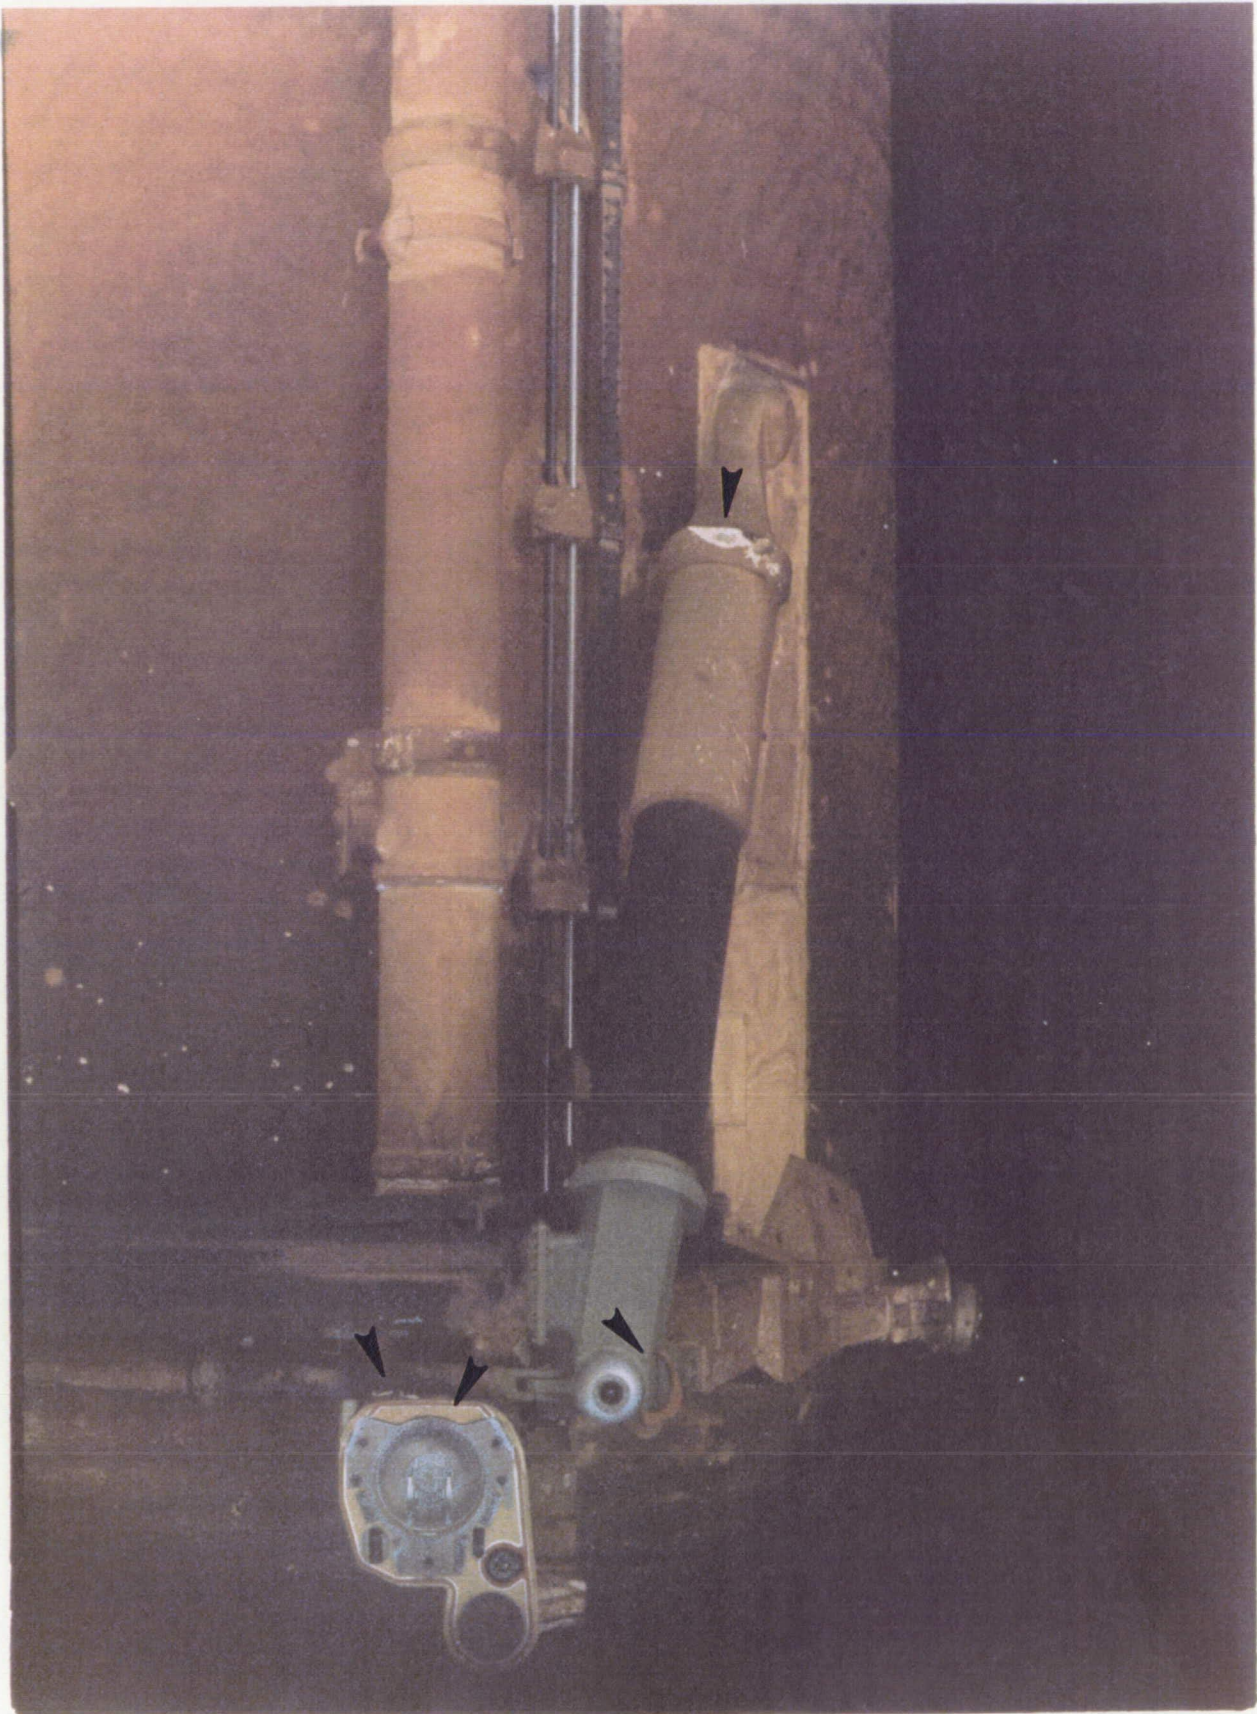
The lightning contact strip was missing from the top of the L02 ET/ORB umbilical (the others were intact). TPS was damaged on the top inboard side of the umbilical. The red seal at the EO fitting was loose and dangling by the retaining cord. Foam was missing from the +Y thrust strut flange and primer/metal substrate was exposed.

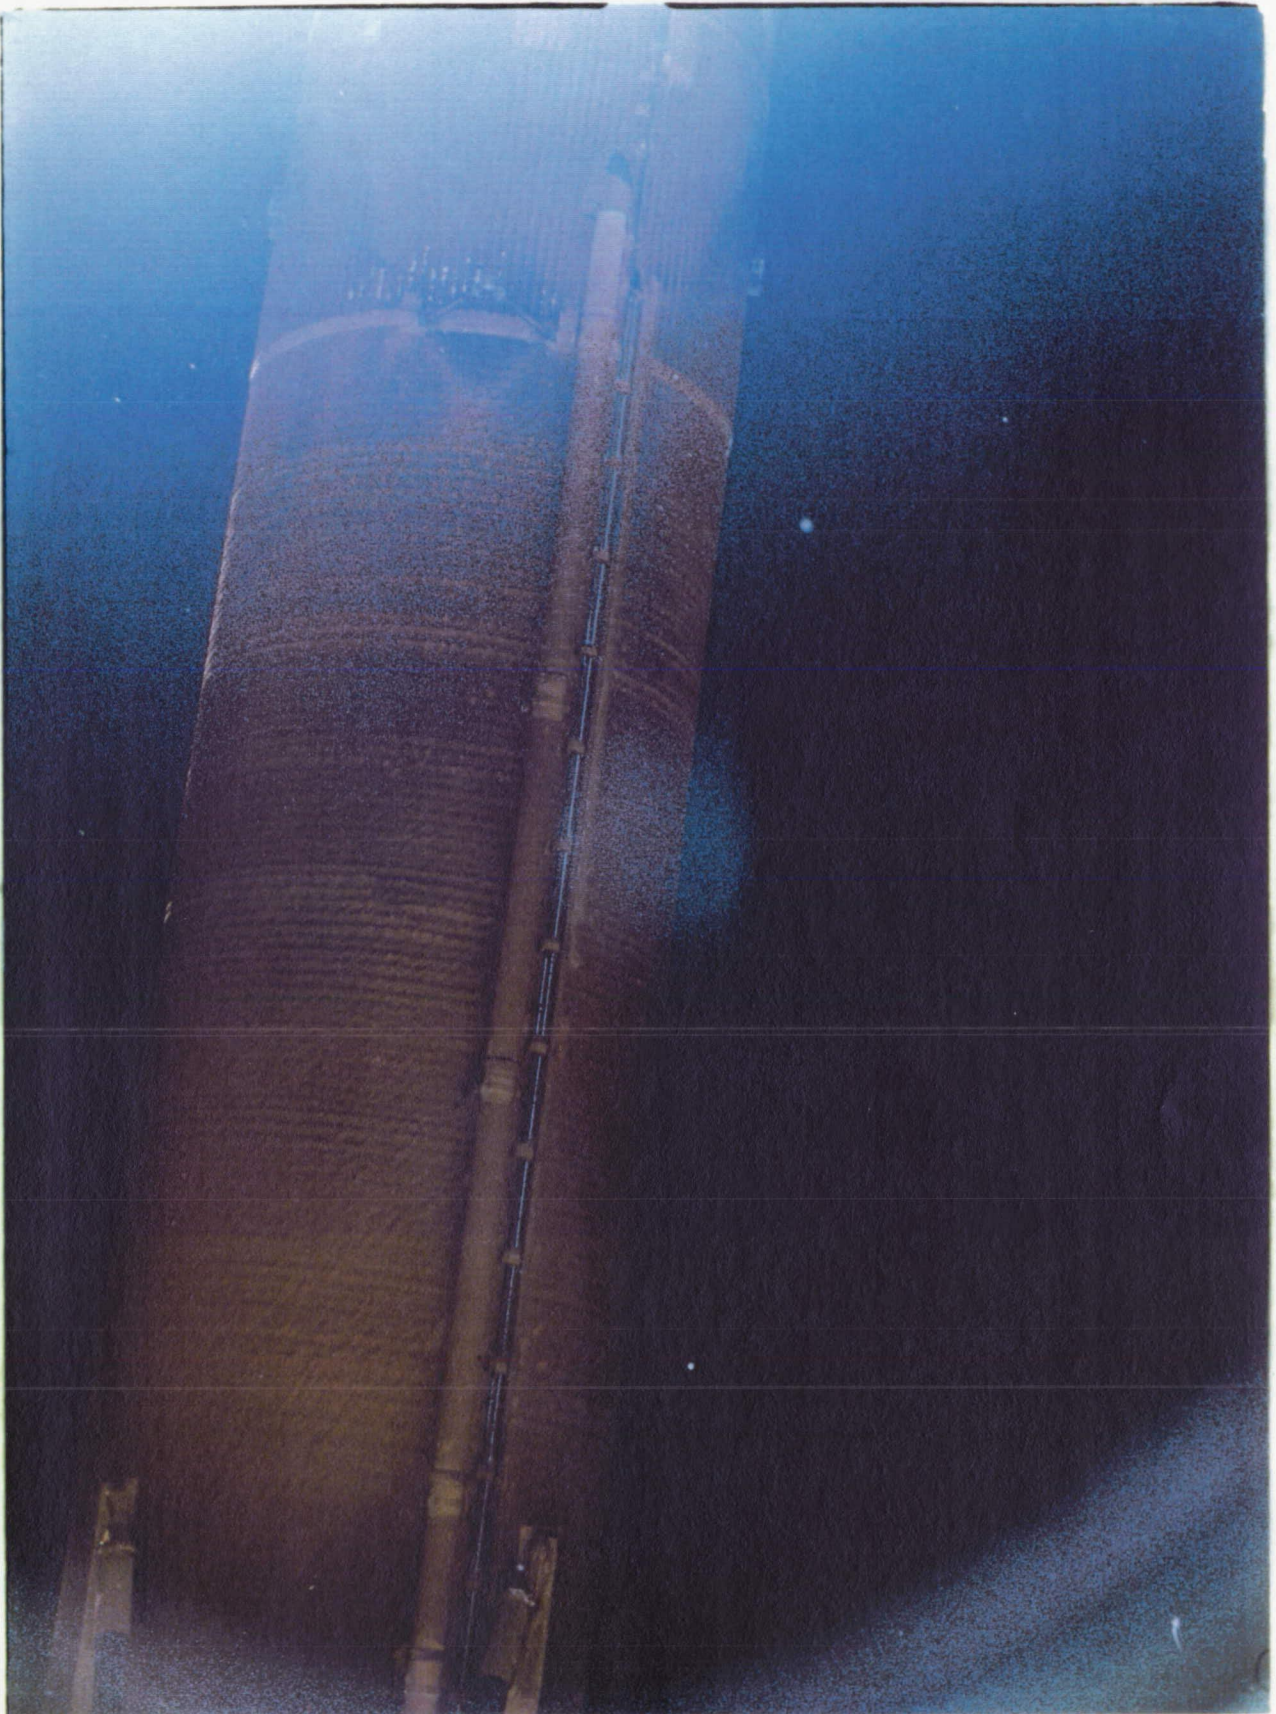
At least 70 small divots, 3-4 inches in diameter, occurred on the intertank stringers forward of the bipods. Seven small divots were visible in the LH2 tank-to-intertank flange closeout between the bipods.

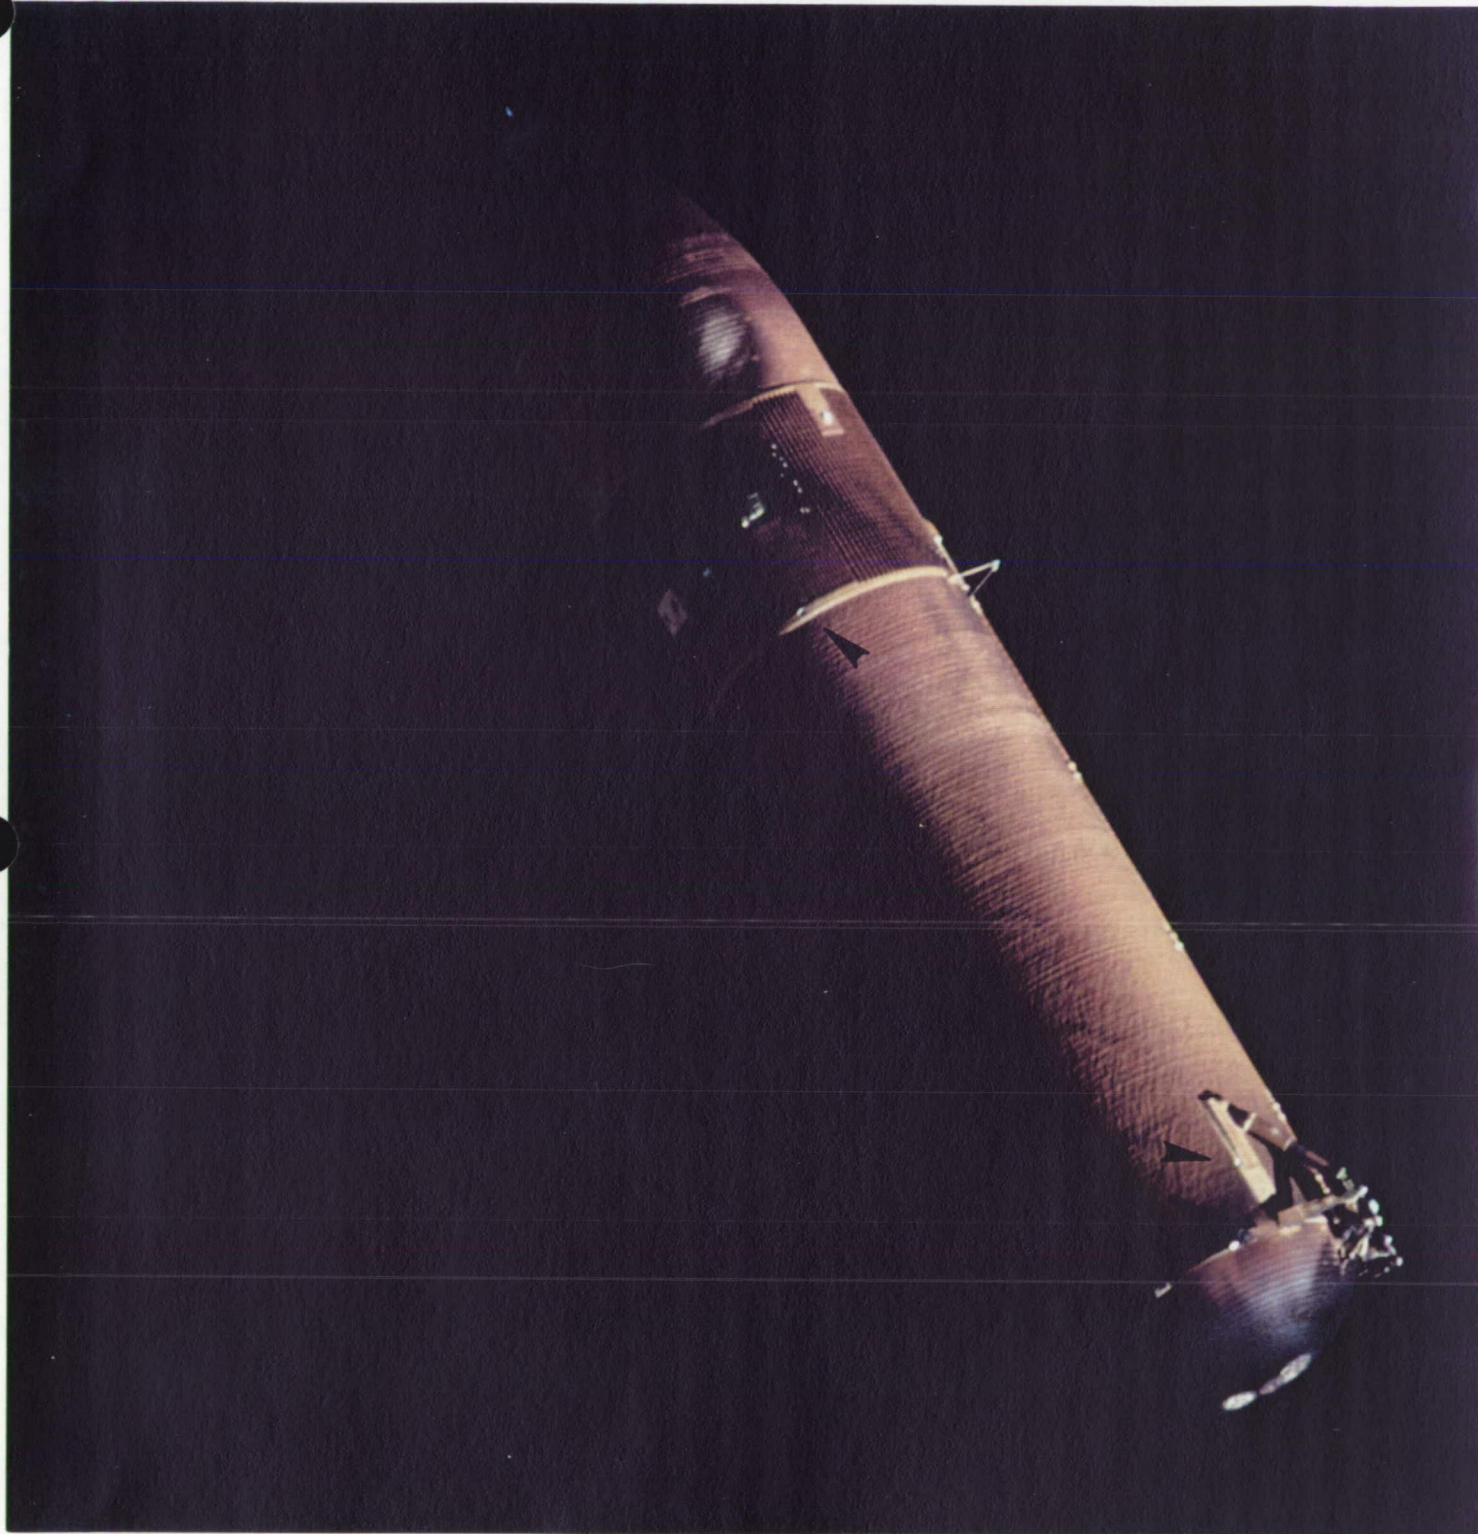
Nine divots occurred in a rough line along the edge of the -Y thrust panel. A divot is visible in the LH2 tank-to-intertank flange closeout and the -Y longeron closeout. There were no TPS anomalies on the LH2 and LO2 tank acreage.

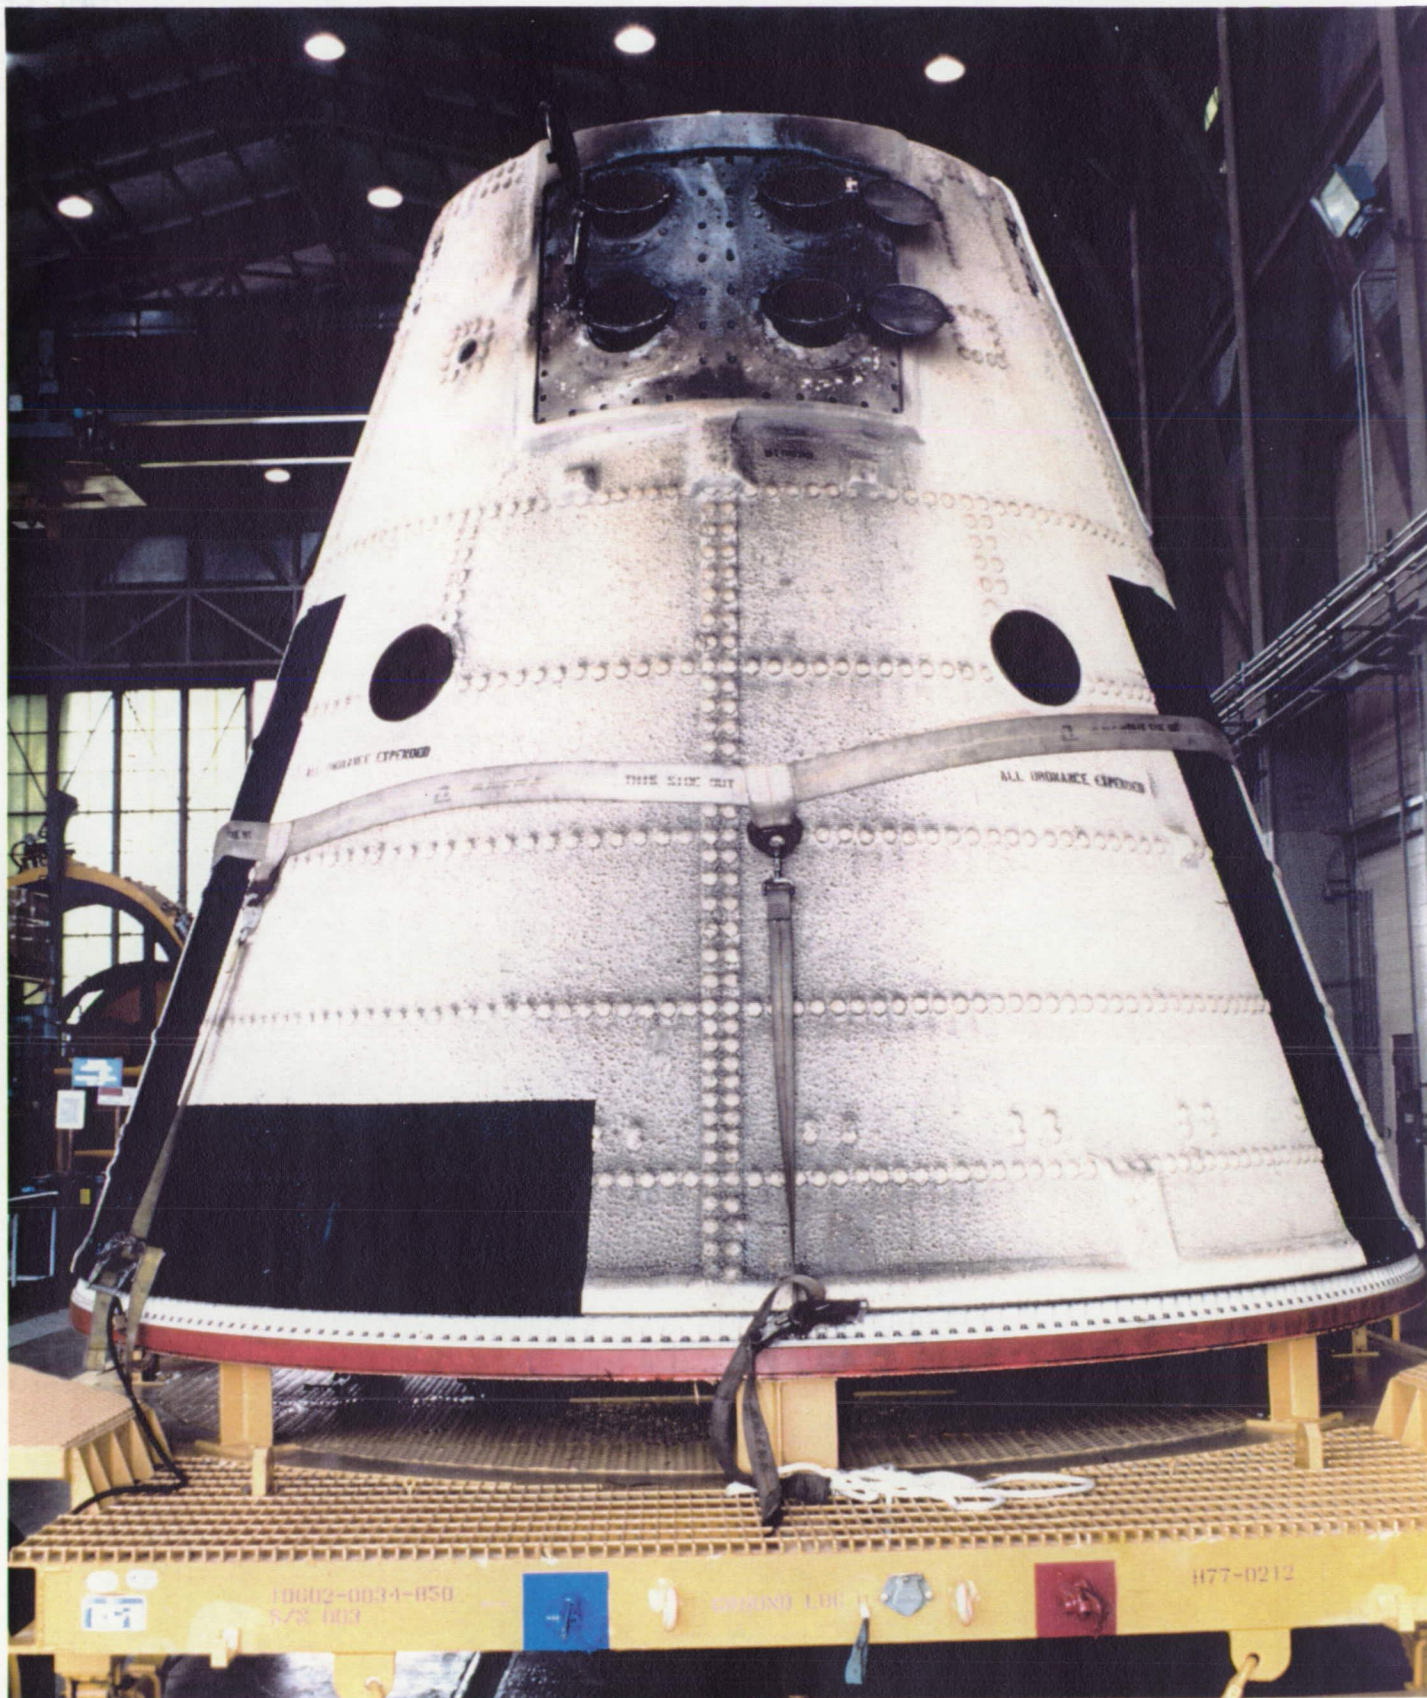
The RH frustum had 46 MSA-2 debonds over fasteners and two areas of missing MSA-2. All BSM aero heatshield covers were locked in the fully opened position, though the two left cover attach rings had been bent by parachute riser entanglement.

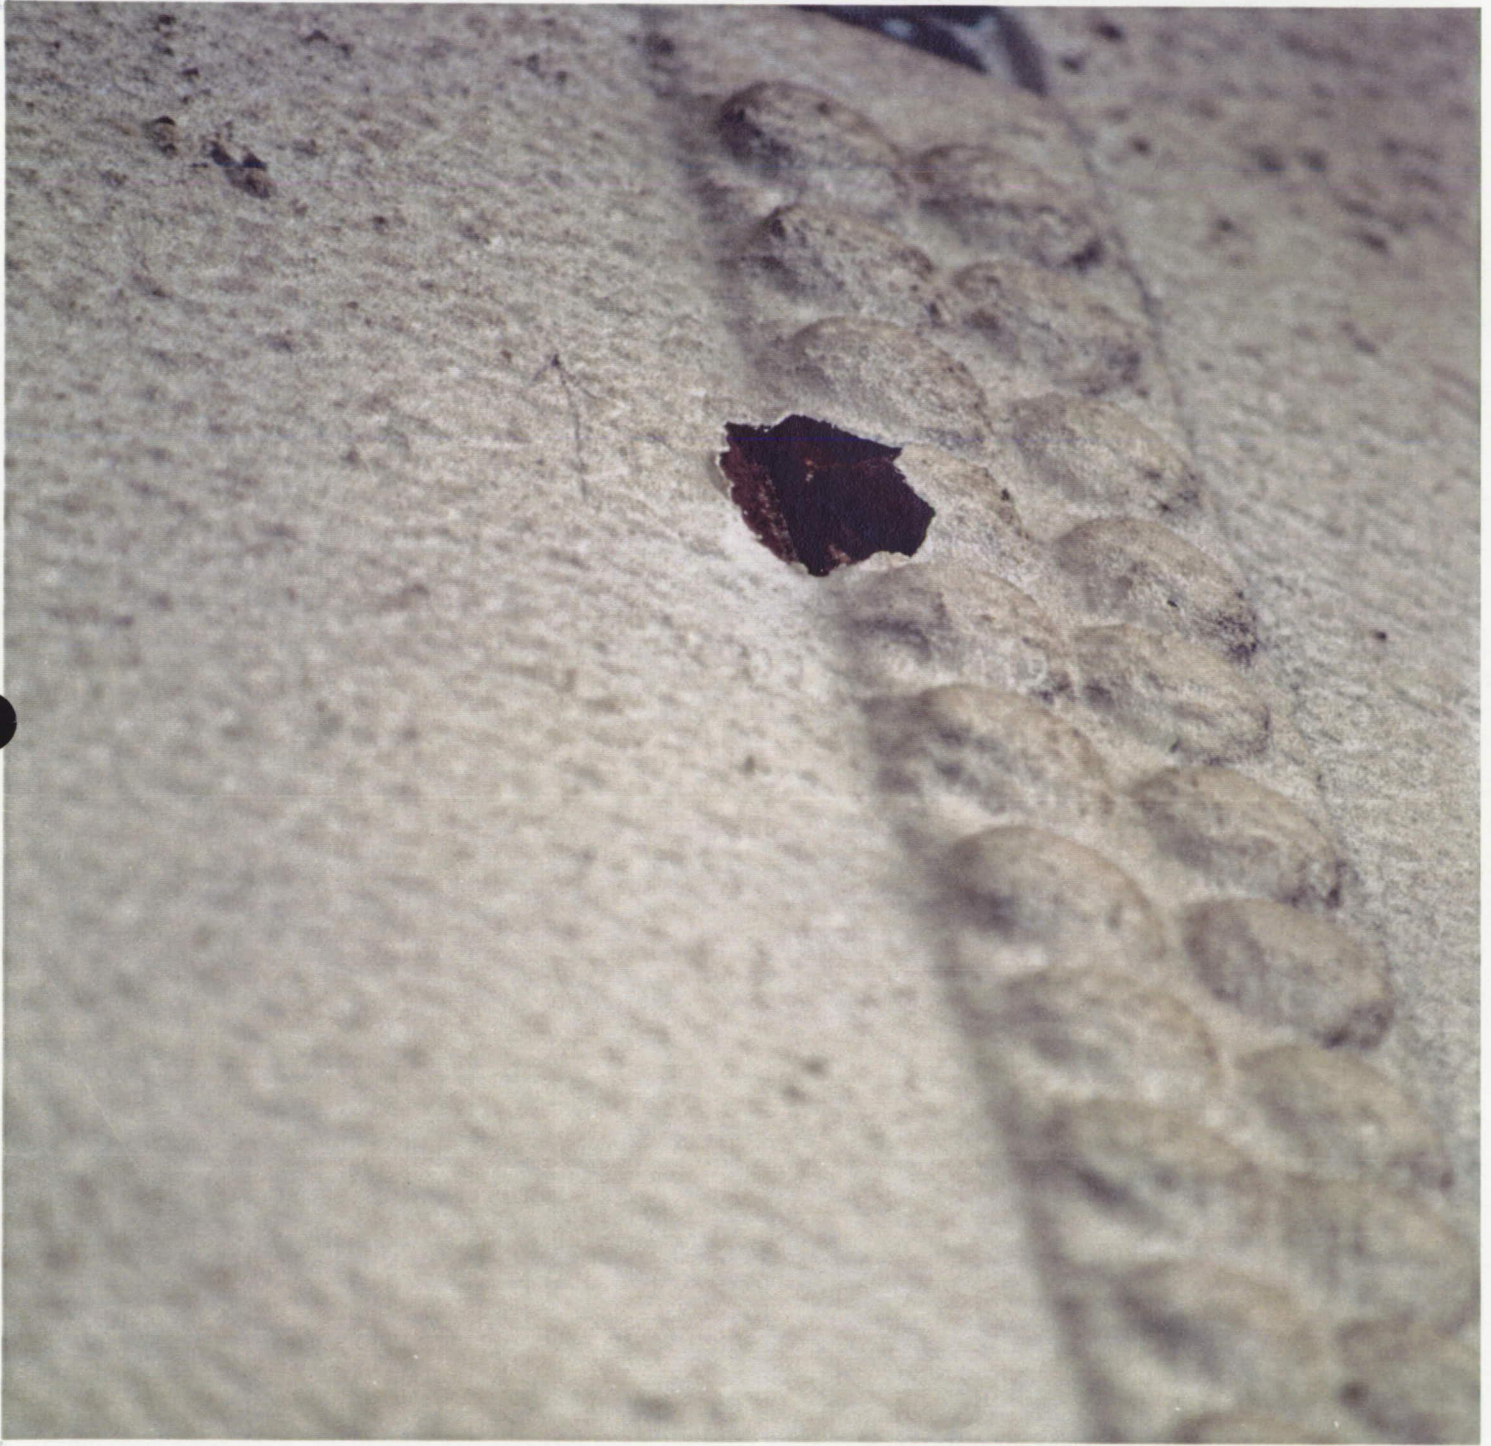
Loss of MSA-2 TPS from a frustum fastener

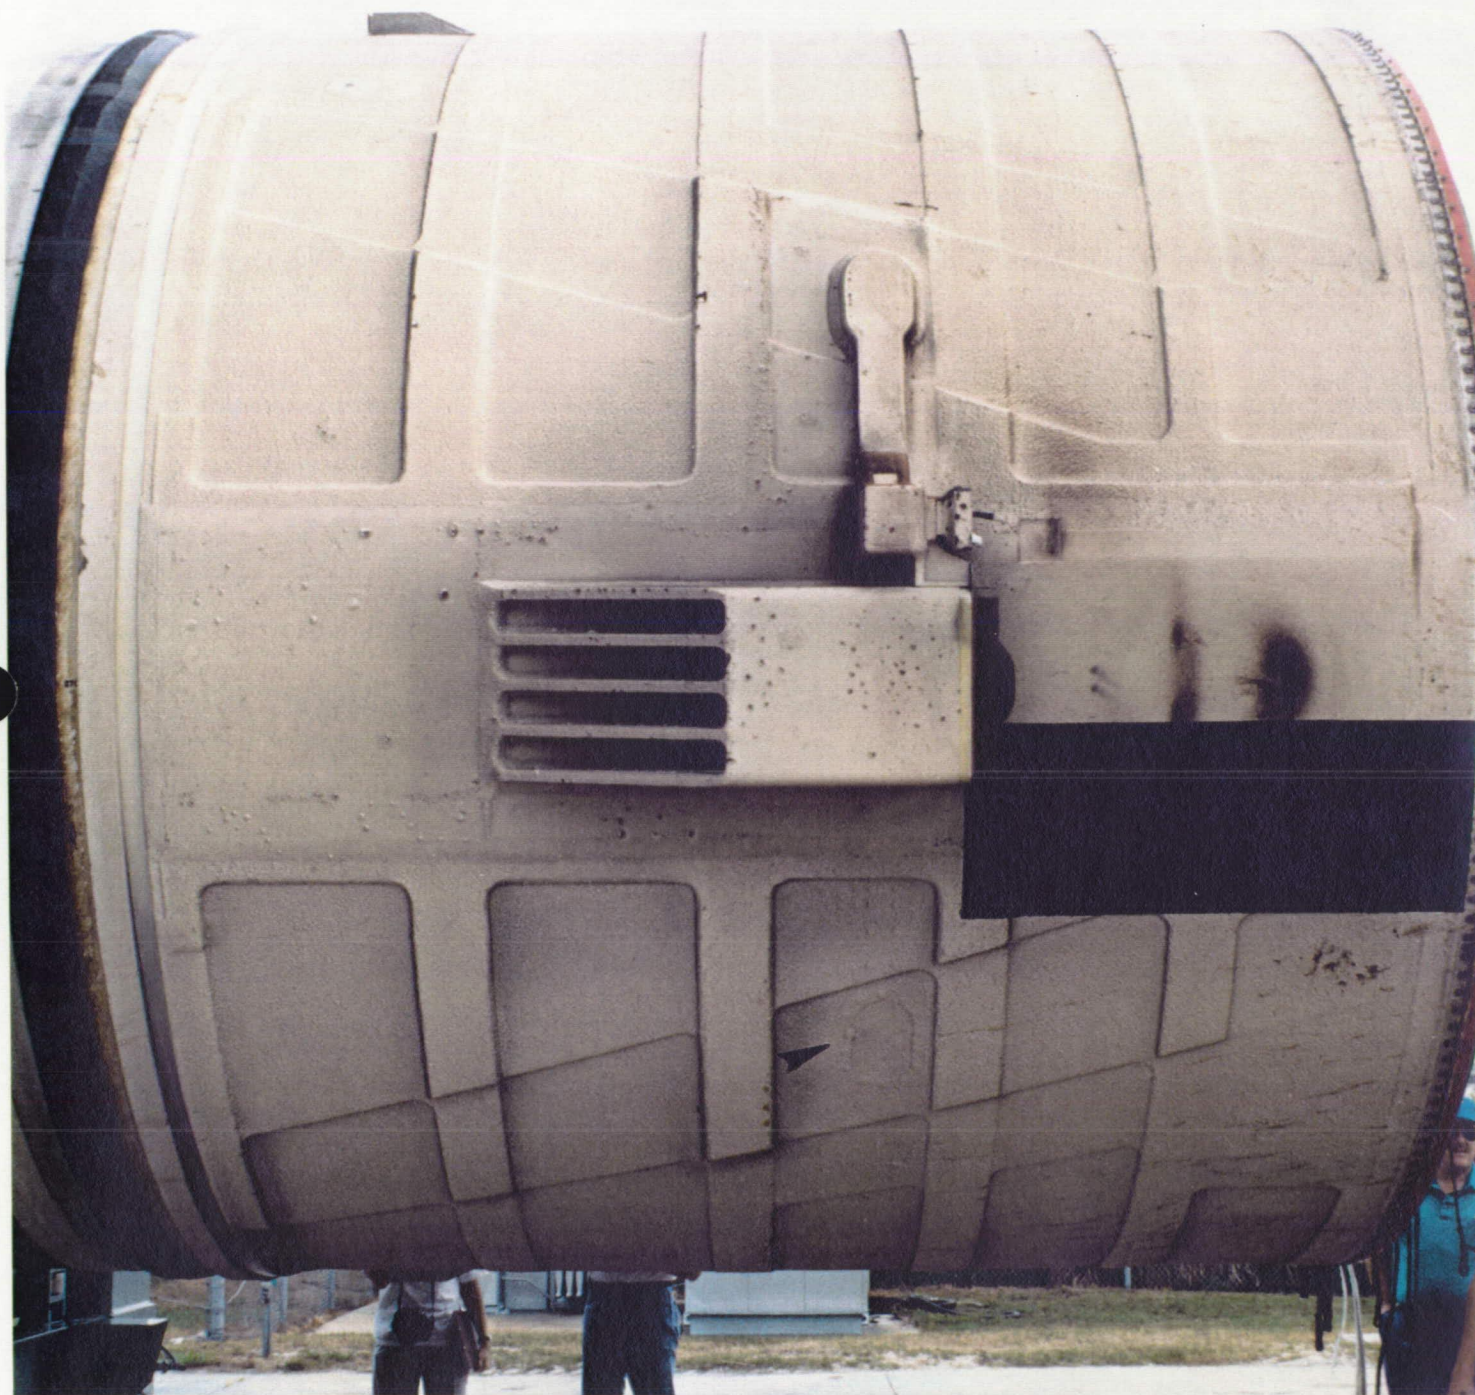
The RH forward skirt acreage MSA-2 was missing no TPS, but had one MSA-2 debond near the forward attach fitting. Both RSS antenna covers/phenolic base plates were intact.

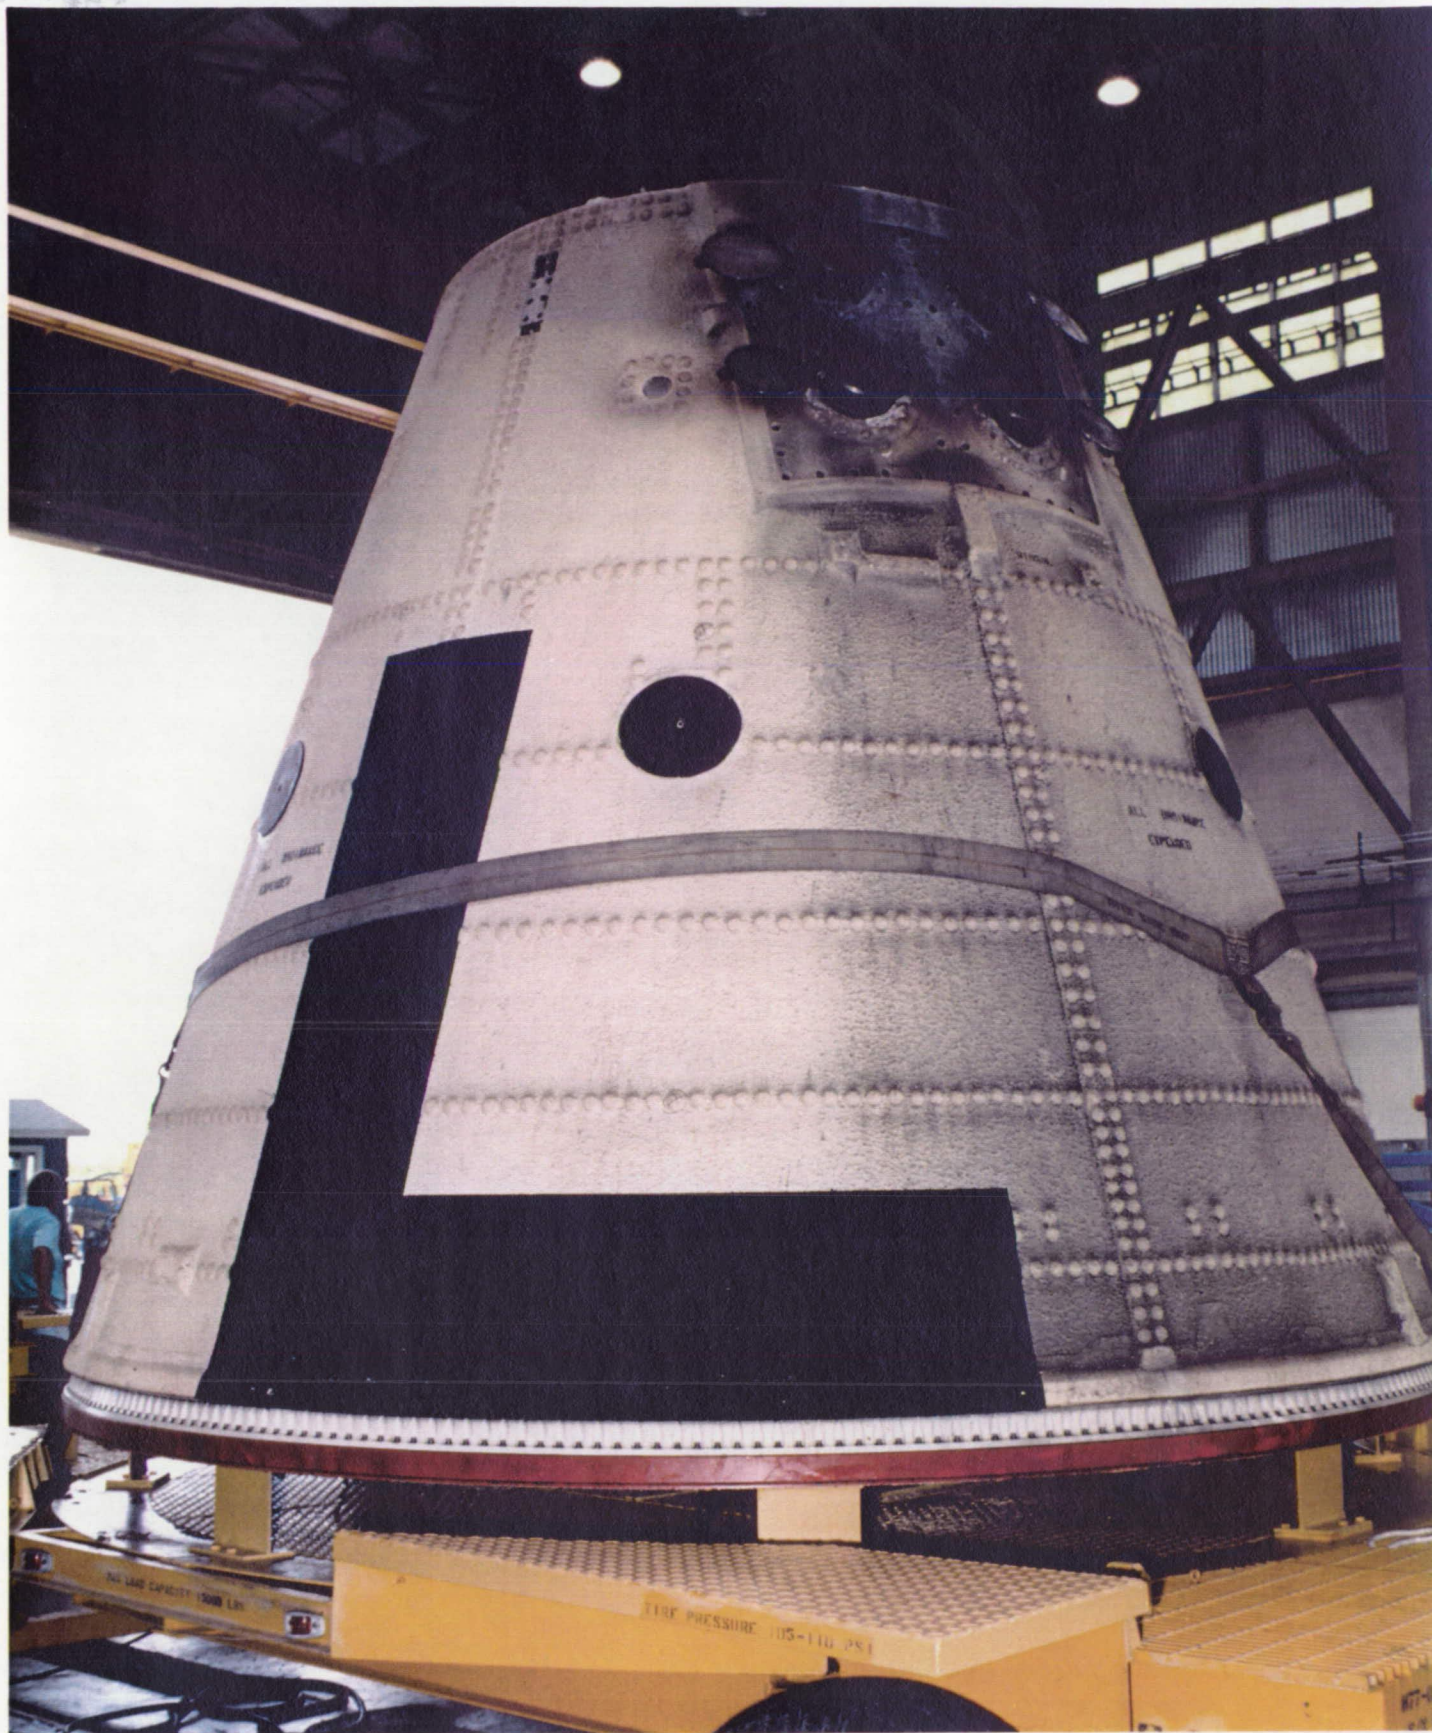
The LH frustum had a total of 27 MSA-2 debonds over fasteners. The BSM aero heat shield covers were locked in the fully opened position.
